Case History: Value Engineering of Driven H-Piles for Slope Stability on the Missouri River

IFCEE 09, Orlando, Florida
March 16, 2009

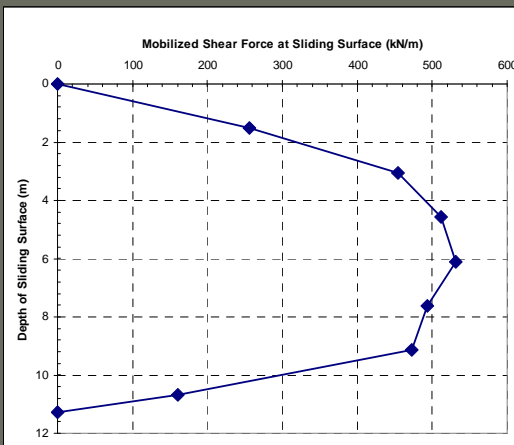
- Lateral pile-soil response: Calculate shear resistance mobilized in the pile at various depths due to soil movement loading the pile

Soil movement = 127 mm (5 in)

Depth increment = 1.5 m (5 ft)

Undrained Shear Strength = 36 kPa (750 psf) to 48 kPa (1000 psf)

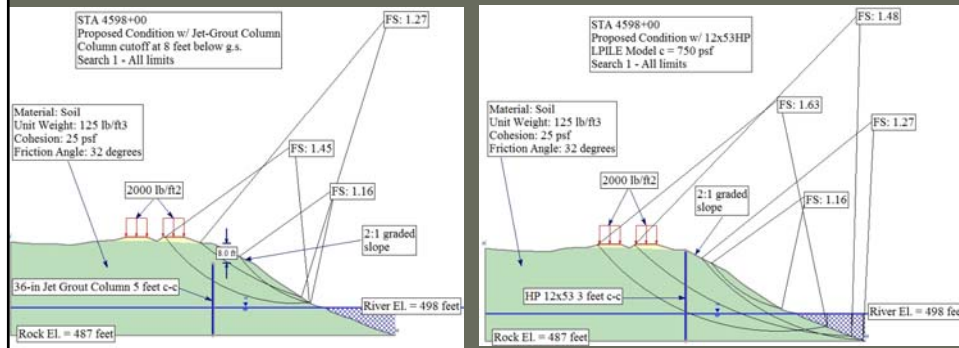
- Embankment stability analyses with the effect of the piles included as a user-defined reinforcement element.
- Comparison of stability analyses using jet-grouted column shear pins to the H-piles.

Results

- H-piles would provide similar or superior stabilization.
- Approx. 10,400 m (34,000 ft) of pile was installed at a cost savings of over \$275,000.
- Piles installation time was about half the estimated time for installation of the jet grout shear pins.
- Additional cost and schedule savings were provided by eliminating temporary work areas required for staging jet grout equipment.
